Health and Safety
Executive

The Explosion and Fire at the Conoco Humber Refinery – 16th April 2001

HSE Investigation and the Lessons Learned

Jonathan Carter
Principal Specialist Inspector
HSE
Hazardous Industries Directorate

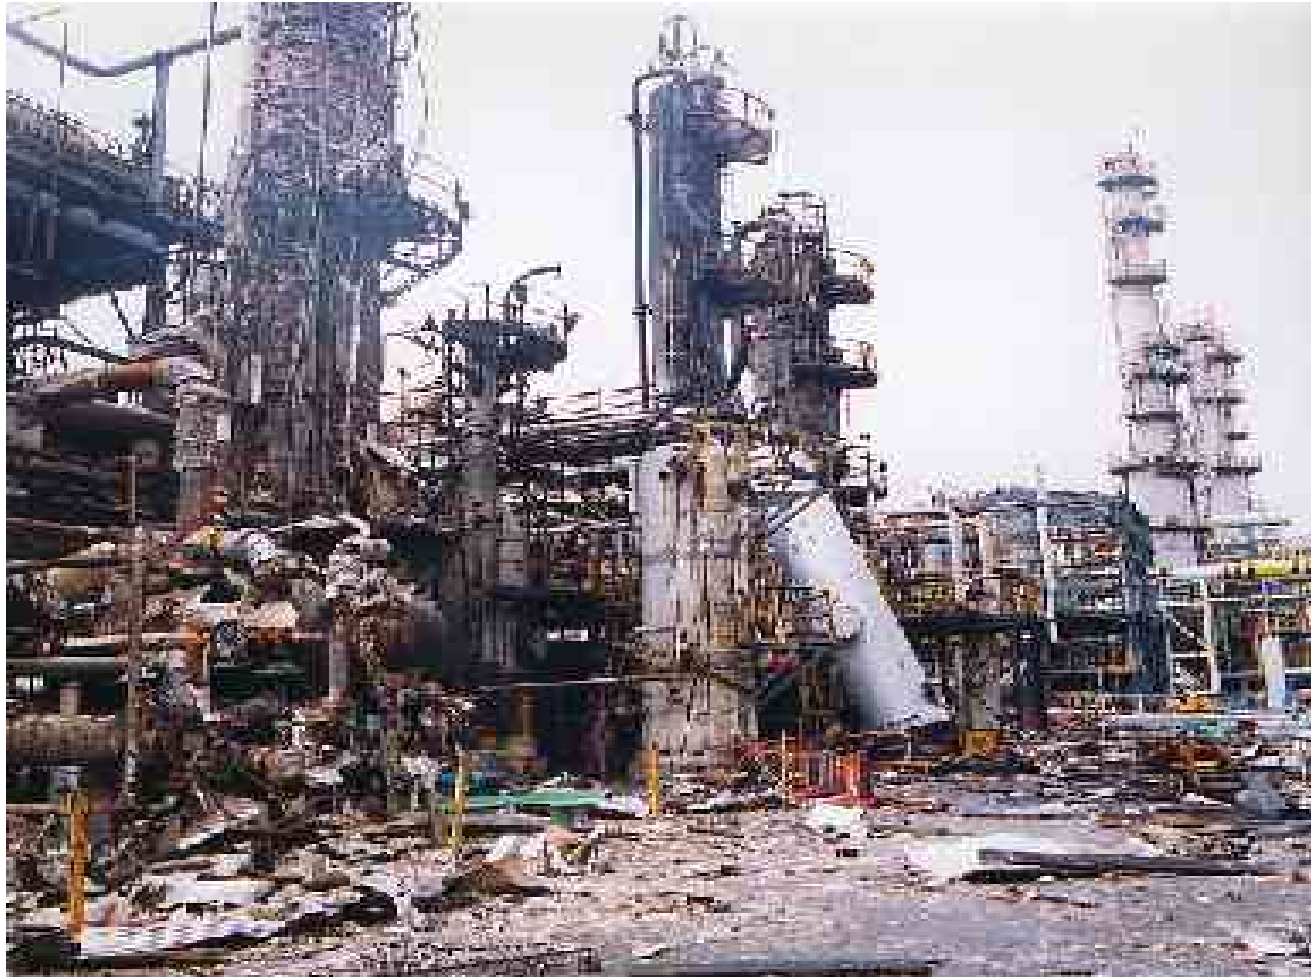
- SGP widespread major damage - write off
- Coker closed blow down system significant damage
- Minor damage to adjacent units
- Minor structural damage to many buildings including main admin. block, stores
- Site wide damage to glazing - canteens, offices
- Site wide damage to cladding, lagging - led to asbestos contamination
- Central control room blastproof - no damage

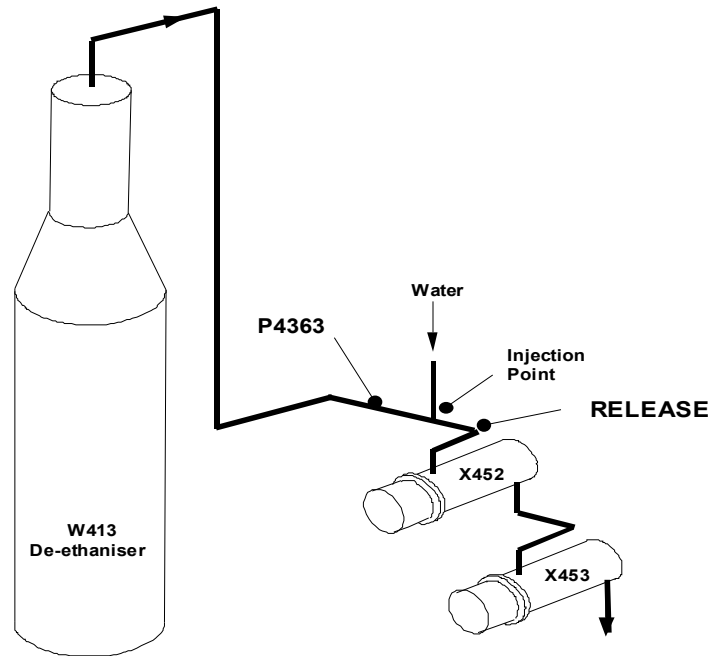
- 14.20 hrs Easter Monday 2001
- Plant running normally, no recent upsets
- Sudden release from de-ethaniser column overheads line (P4363)
- 12m above ground, northern end of SGP
- 0.7 m downstream of water injection point
- Upstream of X452 heat exchanger
- Dispersed into adjacent plant by 7.2 ms^{-1} northerly wind

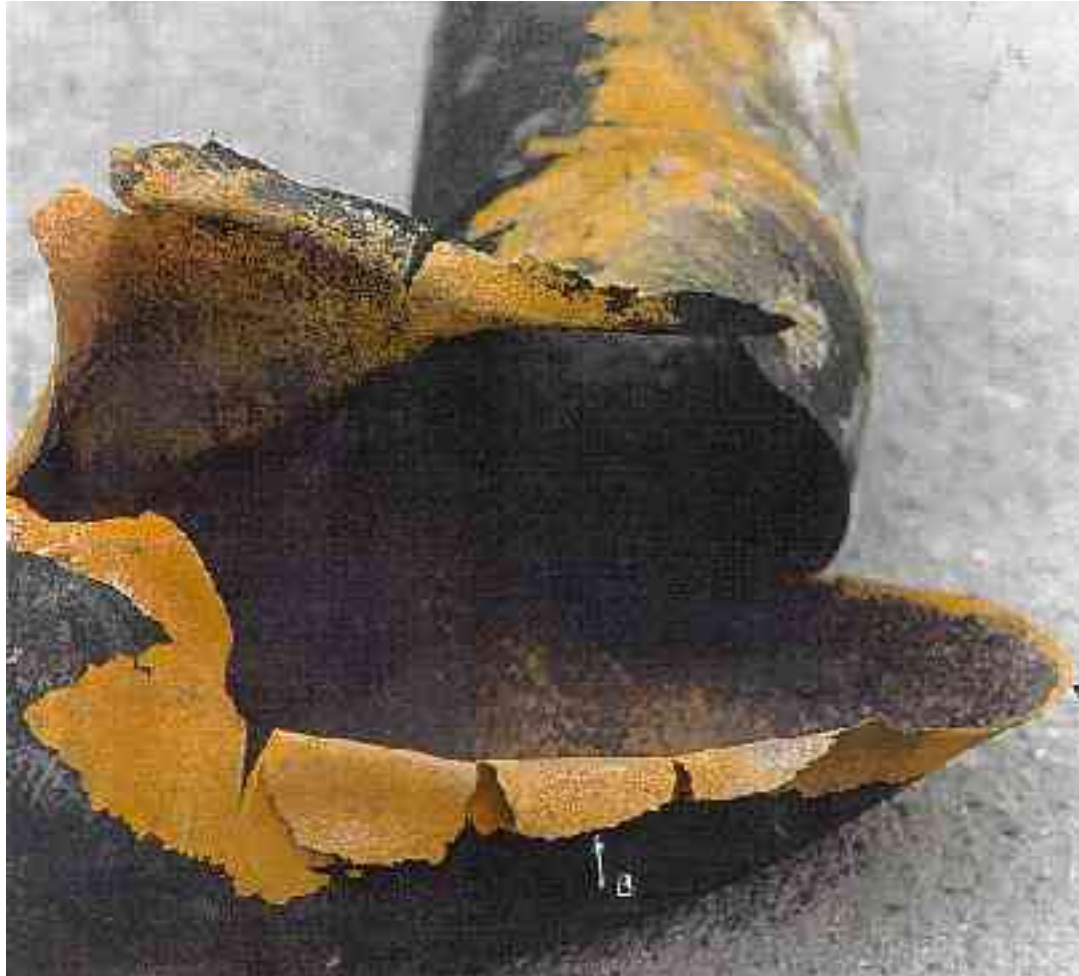
- Catastrophic rupture of 6” diameter overhead pipe (P4363)
- Pipe failed at elbow 67cm downstream of water injection point
- Mild steel pipe, original thickness 7.1mm, reduced to min. 0.3mm, significant area <1mm.

- Degradation due to corrosion-erosion
- Various potential corrosive agents present – ammonia, chloride, hydrogen sulphide
- Injected water sweeping round pipe bend constantly removing passive film of corrosion products – no dispersion device.
